T.K.M. INSTITUTE OF TECHNOLOGY, KOLLAM
DEPARTMENT OF BIOMEDICAL ENGINEERING

Course code & course name: MCN401 INDUSTRIAL SAFETY ENGINEERING

CASE STUDY

Bhopal Gas Plant Disaster (1984)

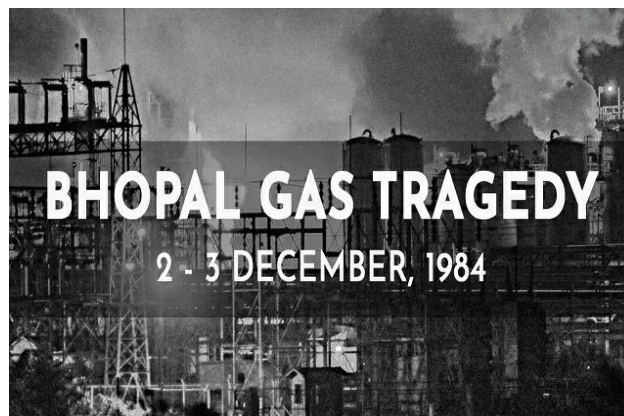
On the fateful night, a massive amount of MIC gas leaked from a storage tank due to a combination of factors, including inadequate safety measures, poor maintenance, and flawed design. The gas quickly spread through the nearby residential areas, affecting thousands of people.

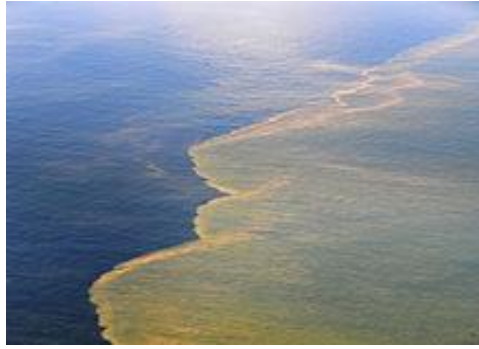
Oil from the Deepwater Horizon oil spill approaches the coast of Mobile, Alabama
