T.K.M. INSTITUTE OF TECHNOLOGY, KOLLAM
DEPARTMENT OF BIOMEDICAL ENGINEERING

Course code & course name: MCN401 INDUSTRIAL SAFETY ENGINEERING

CASE STUDY

Bhopal Gas Plant Disaster (1984)

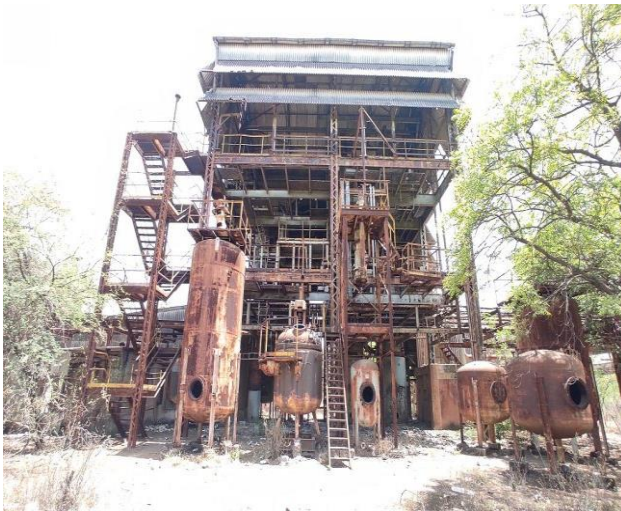
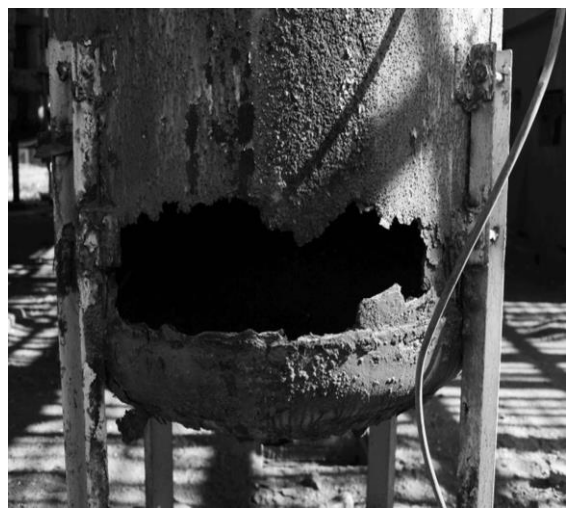
On the fateful night, a massive amount of MIC gas leaked from a storage tank due to a combination of factors, including inadequate safety measures, poor maintenance, and flawed design. The gas quickly spread through the nearby residential areas, affecting thousands of people.

- **Safety Systems Failure:** The plant's safety systems were not properly maintained, and key safety equipment, such as the refrigeration unit for the MIC storage tank, was malfunctioning.
- **Inadequate Training:** Workers were not adequately trained on emergency response procedures, and many were unaware of the potential dangers of MIC.
- **Cost-Cutting Measures:** Union Carbide had implemented cost-cutting measures, compromising safety standards and maintenance protocols.

1. **Immediate Safety Audits:** Conduct immediate safety audits of chemical plants globally, with a focus on high-risk substances.
2. **Enhanced Emergency Response Training:** Implement enhanced emergency response training for industrial workers.
3. **Global Safety Standards:** Advocate for and implement standardized global safety regulations for industries dealing with hazardous substances.
4. **Corporate Accountability:** Strengthen regulations to hold corporations accountable for safety negligence, ensuring the well-being of both workers and surrounding communities.
5. **Community Preparedness Programs:** Develop and implement community awareness and preparedness programs to equip residents living near industrial areas with knowledge on potential risks and emergency procedures.

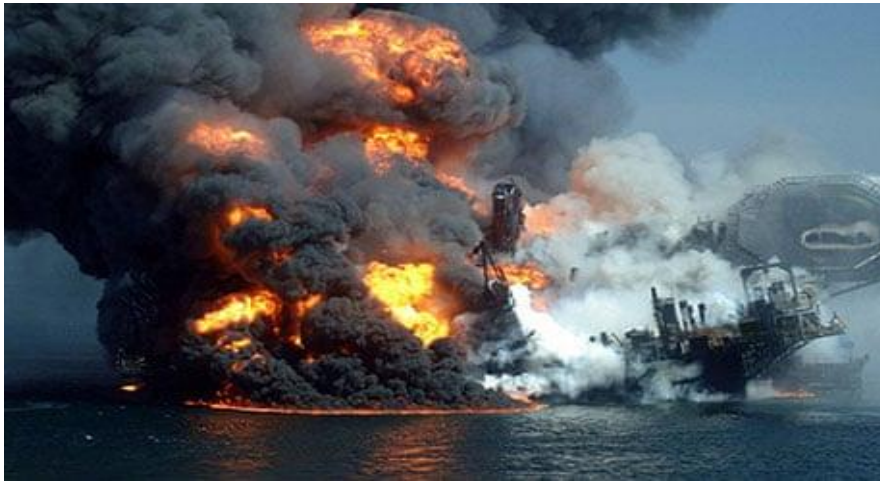
The Deepwater Horizon rig, operated by BP, suffered a blowout while drilling an exploratory well, causing a catastrophic explosion and subsequent oil spill. The incident resulted in the loss of lives, extensive environmental damage, and severe economic repercussions. The oil spill released millions of barrels of crude oil into the Gulf of Mexico, causing widespread ecological damage, harming marine life, and affecting coastal communities. The economic impact on the fishing and tourism industries was substantial.

Blowout and Explosion: The blowout preventer (BOP) system, designed to prevent the uncontrolled release of oil and gas, failed to activate, leading to the explosion.

Safety Culture: BP's safety culture was criticized for prioritizing cost-cutting over safety, leading to inadequate training, maintenance, and equipment testing.

Technological Innovation: Invest in research and development for advanced drilling technologies and fail-safe mechanisms to prevent blowouts.
